Engineering Analysis

The conclusion reached in the Condition Assessment for the Going-to-the-Sun Road states that a majority of the Road is in need of extensive rehabilitation in order to be responsive to the issues of public safety, environmental concerns, preservation of historic features and natural resources, socioeconomic impacts, transportation needs, and overall visitor experience. Our findings support previous analyses of the Road that also recommend expediting rehabilitation efforts in order to ensure the integrity of this National Historic Landmark for future generations.

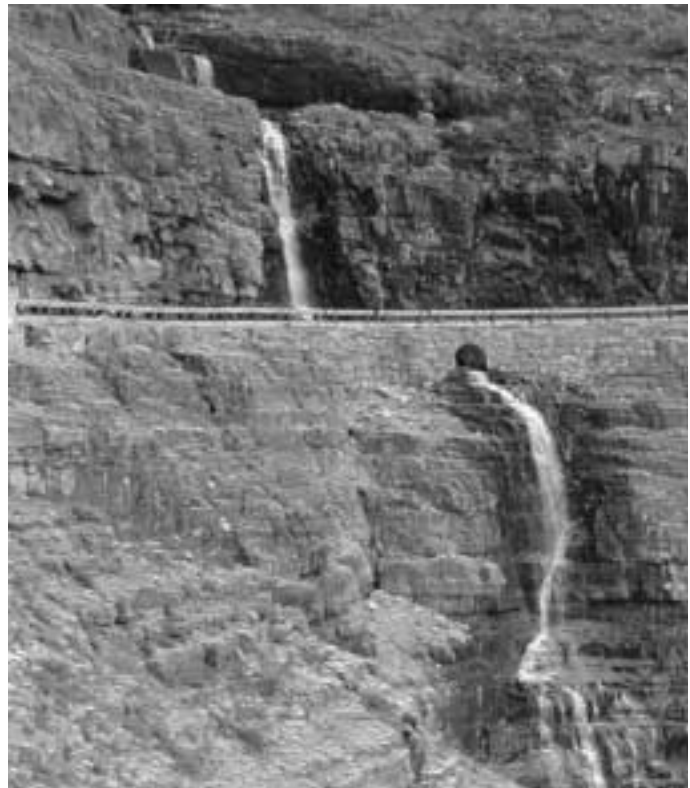
Figure 31:
Tumbling waters pass under
Going-to-the-Sun Road as it
makes its way to Triple Arches.
One of the trademark structures
that supports the Road, Triple
Arches is in dire need of
rehabilitation.

- **Triple Arches: MP 30.1.** The triple arch masonry roadway support, approximately 50 feet in length, provides support for the Road over precipitous cliff areas. Its condition is fair to poor. The lower rock cliff support for this structure has failed, necessitating intermediate corrective action (rock bolts, grouting of cracks in the cliff, and steel beam lateral support devices). In addition, to provide a minimum guardwall height in this area, the roadway template should be lowered for the full roadway width. Improvements to this structure have been designed by FHWA and should be implemented as soon as funding is available. The stone masonry of the structure and associated guardwall is in need of repointing and repair.

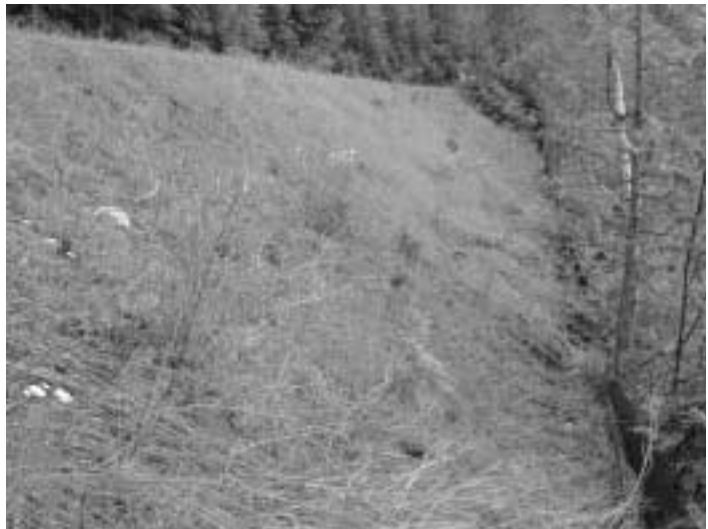
Slope Stability: Two areas of roadway slumps are noted in this section, at MP 6.4 and MP 9.4. At MP 6.4, lake erosion is occurring at the toe of a previously constructed

Landslide Segment: MP 6.3 to 9.1. Lake erosion is occurring at the toe of the slope of the previously repaired slump failure (FHWA Wall 05.90). In order to retard further erosion, erosion protection should be applied at the toe of the repaired slope at lake level, such as placement of large rip-rap at the lake level and rows of erosion logs.

Figure 33: Lake erosion at the toe of the slope, MP 6.4

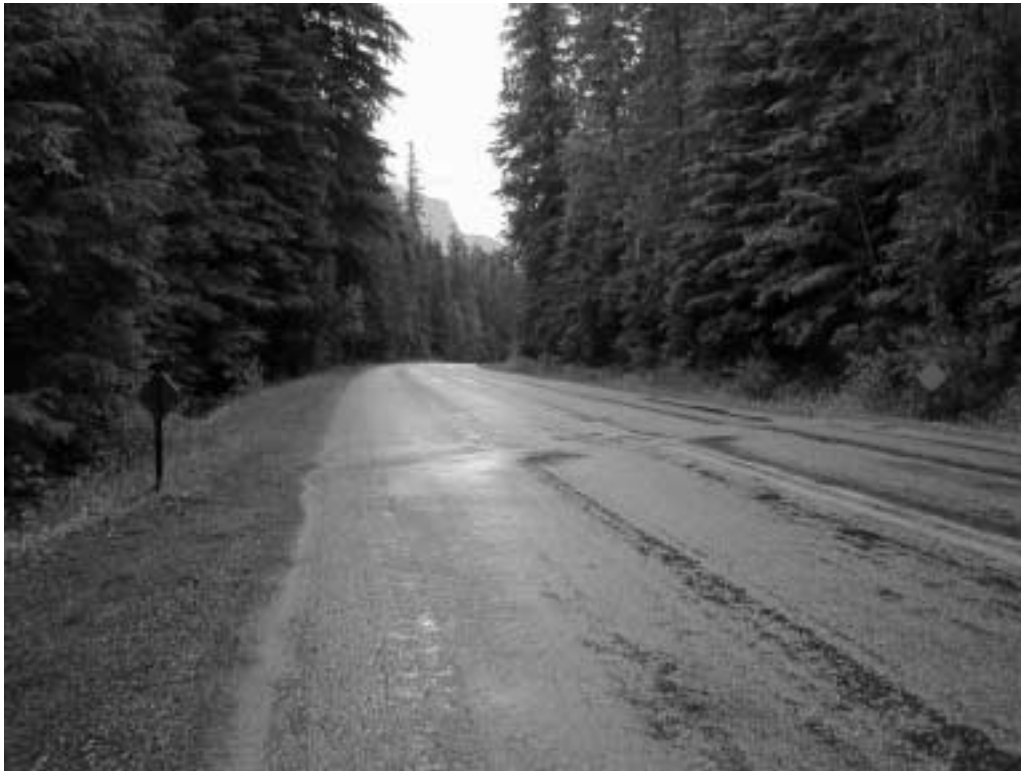
tie-back retaining wall. At MP 9.4 a fairly large slide is active and monitoring of the roadway pavement and foundation should be re-established.

Figure 34: An active slide at MP 9.4

A fairly large active slide has been previously investigated and monitored by the FHWA in the vicinity of MP 9.1. This slow-moving slide is estimated at 60 feet deep by 600 feet long by 500 feet wide as it affects the Road. There is a noticeable subsidence of the pavement in this area. The FHWA has identified this site as a significant deficiency; however, the roadway does not appear to be in imminent danger of sudden failure, and this slide is not considered a priority at this time. Periodic monitoring of this landslide should be re-established to detect any acceleration of the slide's movement that could cause sudden, major damage to the Road. Mitigation measures may be needed if impacts to the Road section accelerate.

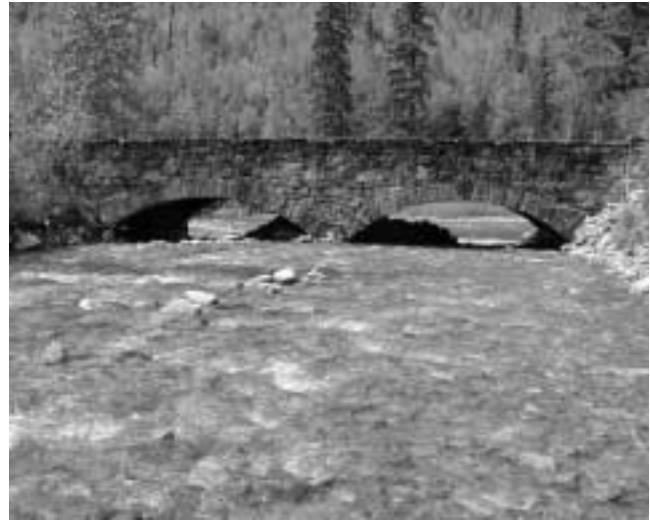
- **Logan Creek Stream Crossing: MP 20.9.** This two-span concrete arch with stone masonry facing bridge is 43 feet long by 22 feet wide (across the Road). Its general condition is fair; however, it is narrow and appears to have inadequate hydraulic capacity for peak flows. The streambed rock and debris load is very heavy during high water conditions and is a continuing source of maintenance problems as illustrated in Figures 36 and 37. Dredging of the streambed is recommended and rip-rap should be placed to reduce the scour that is occurring along the footer. A cofferdam will be necessary to move the flow to one culvert while cleaning the other. Dredged material could be sorted and used for fill in other locations.

Figure 36: Logan Creek Bridge

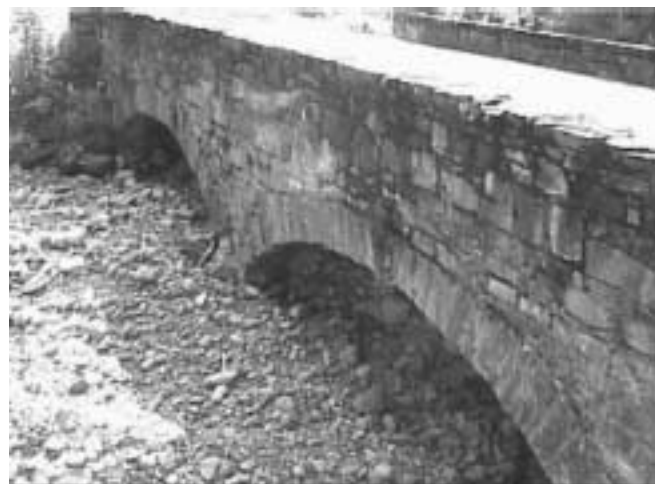
Figure 37: Rock and debris nearly fill the bed of Logan Creek

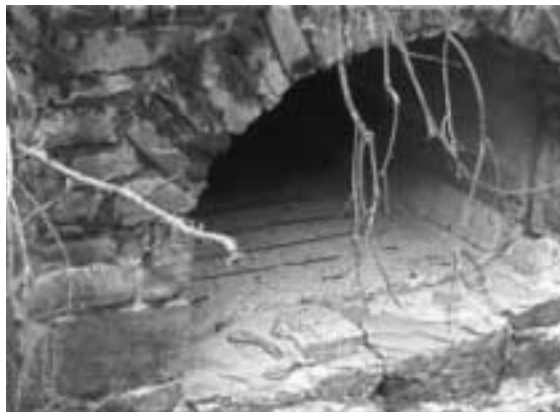
Figure 38: Abrasion on the bottom slab of Haystack Creek stream crossing

- **Haystack Creek Stream Crossing: MP 21.5.** This stone arch culvert with concrete bottom slab is an approximately four by six foot concrete box culvert 24 feet long. The arch support is in fair condition; however, the bottom slab has been badly eroded and is in very poor condition. Reinforcing steel bar is exposed and there are numerous cracks and broken areas in the concrete, as illustrated in Figure 38. The crossing is undersized for the flows and high bed loading is evident. Dredging is recommended and the material could be sorted and used for fill in other locations. An additional concrete box culvert could be added to this crossing to address the flow constraints.

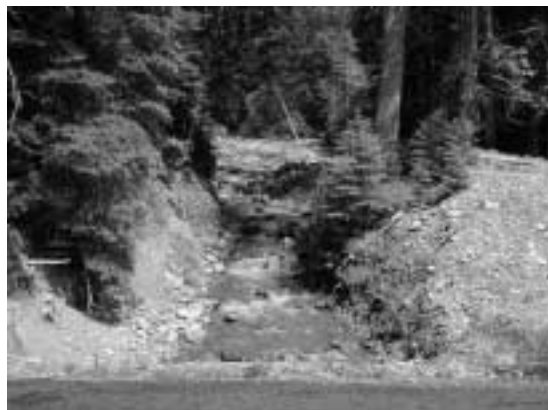
Figure 39: Debris accumulation along Haystack Creek

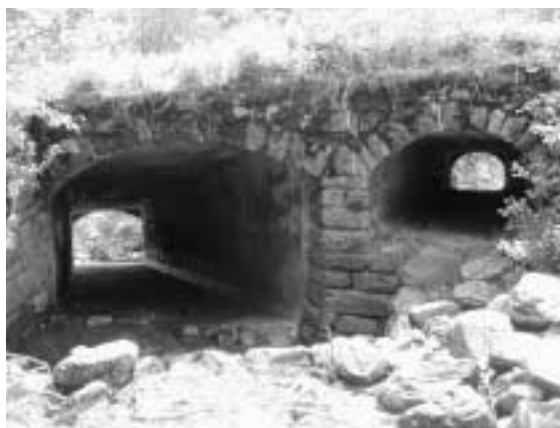
Figure 40: Double box culvert, Alder Creek Stream Crossing

- **Alder Creek Stream Crossing: MP 22.6.** This double concrete box culvert with stone parapets has one ten by eight foot barrel and one six by four foot barrel, each approximately 22 feet long. Both culverts are in fair condition except for moderate to minor erosion of the bottom slabs. Grout loss is evident and separation of the headwall and bottom show signs of scour. The stream bed load of rock and debris limits the capacity of these structures during high water conditions and should be dredged. Repair to the headwall and wingwalls is recommended along with abrasion plating of the bottom slab and placing rip-rap at the outlet.

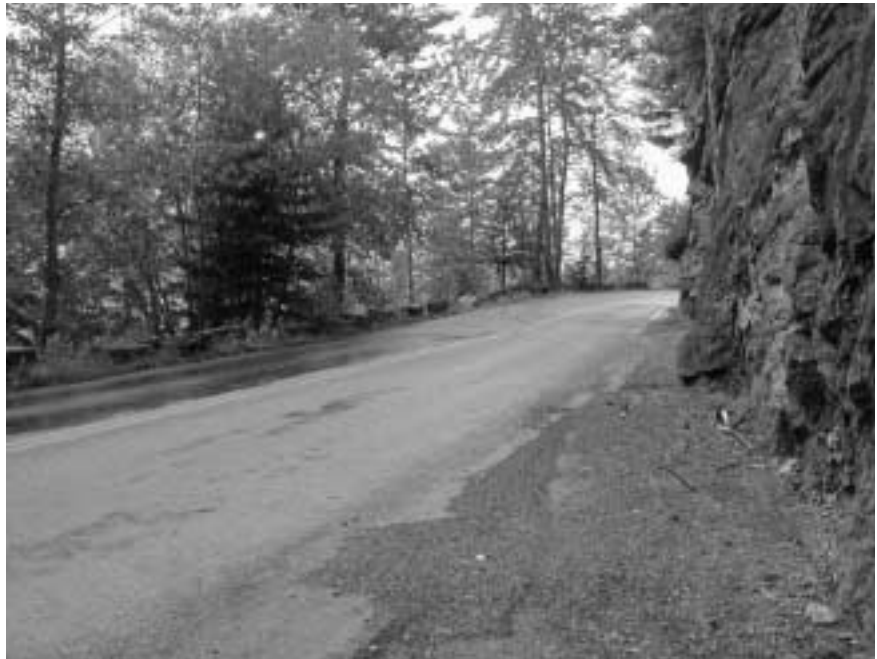
- **West Tunnel Approach Segment: MP 23.0 to 23.3.** Roadway drainage in the vicinity of MP 23 is deteriorating. Approximately 150 feet of walls and a concrete pan with drop inlet are recommended to curtail the drainage. The concrete retaining wall with removable railing near MP 23.1 is not crash-tested and not historical. One alternative is to cut the concrete wall at road level, build a core wall and face with appropriate stone on both sides. Approximately 100 feet of stone retaining wall at MP 23.12 has impact damage, grout deterioration, and settlement and requires template rehabilitation with sub-excavation and mortar point and patch-work. Approximately 70 feet of guardwall is tipping at MP 23.19 and should be removed and replaced on a 4 foot slab with drop inlet. The concrete culvert inlet at MP 23.25 is in disrepair and requires replacement with a weathering steel, close-mesh grate. The road at MP 23.25 is experiencing creep and settlement and should be reconstructed with at least an eight foot slab with anchors keyed with the toe wall.

Figure 41:
Roadway
drainage below
the West Tunnel

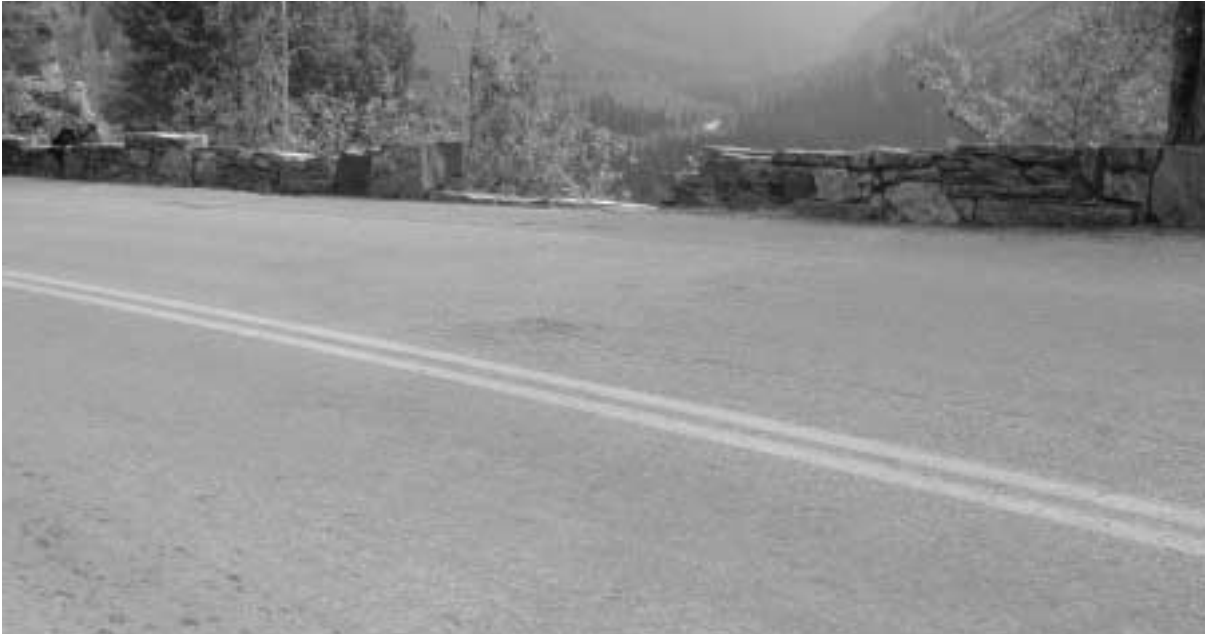
Figure 43: Missing section of guardwall near MP 24

at the roadside waterfall. At MP 23.68, 20 feet of guardwall is missing and needs reconstruction on a 4 foot slab along with a new trench drain across the road. The retaining wall at MP 23.75 (FHWA Wall 23.44) has broken stones and grout cracking and requires repointing. The retaining wall at MP 23.75 (FHWA Wall 23.47) is moving and grout is failing and needs repair, currently slated for this year. The retaining wall at MP 23.8 (FHWA Wall 23.51) shows some grout cracking and the road is subsiding in this area. Repair of this area requires template rehabilitation as well as mortar repointing. The retaining wall at MP 23.84 (FHWA Wall 23.54) has tilted and moved and requires rehabilitation, currently scheduled for 2004. The rock face above the Road at MP 23.88 has loose rock and requires scaling. Approximately 300 feet of concrete valley pan with outlets are needed at MP 23.9 to address the drainage against the walls. The retaining wall at MP 23.9 (FHWA Wall 23.64) requires rip-rap to control the toe erosion. The retaining wall at MP 23.9 (FHWA Wall 23.64) is failing and should be rebuilt on a concrete footing. The retaining wall at MP 23.98 (FHWA Wall 23.66) shows settlement and erosion at the footing and requires rehabilitation, currently slated for 2004. The rock face above the Road at MP 23.98 has loose rock and requires scaling.

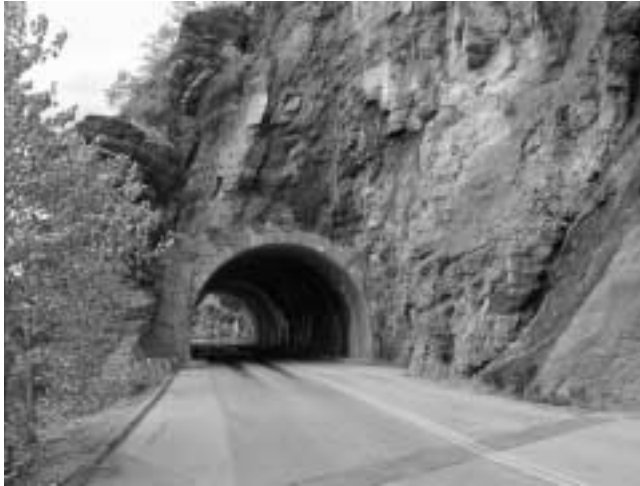
Figure 44: South portal of West Tunnel

- **West Tunnel: MP 23.6.** The concrete tunnel, which is 205 feet long and 22 feet wide, is generally in good condition. The rock masonry on the west and east portals of the tunnel is crumbling and in disrepair and repair is needed. The concrete lining shows numerous cracks along the entire length of the tunnel which appear to have been healed by natural processes and are not considered a structural problem at this time. The window ports in the tunnel are in fair condition with the exception of some loose rock on the outside of the ports that should either be scaled or bolted. The pavement is in fair condition with few cracks or undulations.

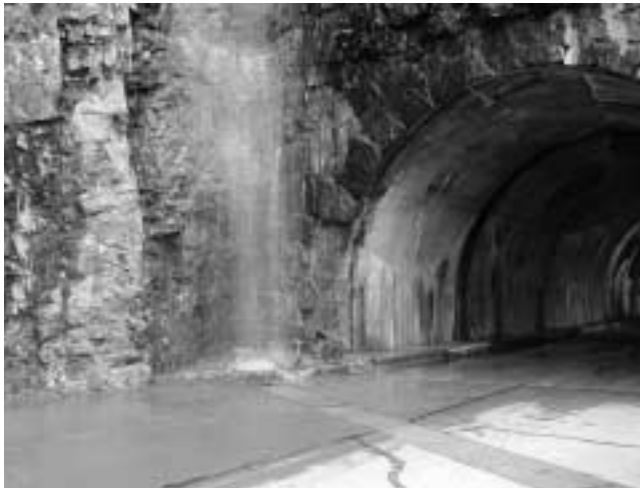
Figure 45: North portal of West Tunnel

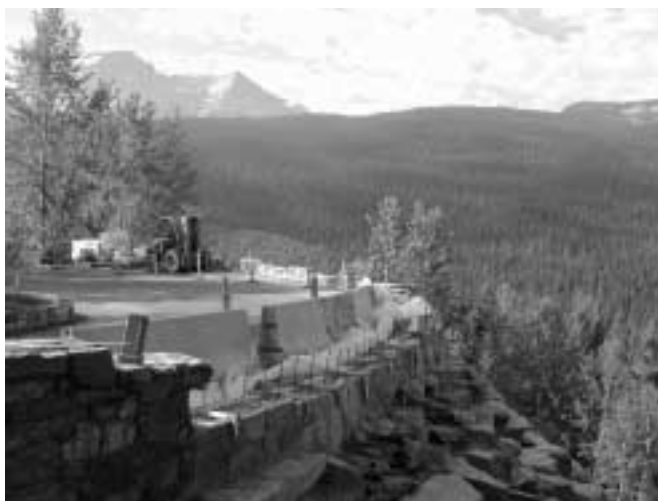
- **The Loop: MP 24.2.** The dry stack wall and drainage at The Loop is currently under rehabilitation and construction techniques, traffic control methods and workmanship were reviewed. The overall design appears adequate with the exception that pedestrians using the Granite Park Trail must cross the road with minimal sight distance, a condition that should be addressed. Drainage in the Loop parking lot requires an outlet to evacuate standing water. Also within the Loop parking lot, some impact damage to guardwall was noted, along with about 200 feet of undermined guardwall, which could be repaired by grouting. Traffic control operations appear to work well. Workmanship, in general is good, however, more attention could be paid to the stone masonry work to achieve a more historically acceptable look on all sides of the walls.

Figure 46: Construction at The Loop, June 2001

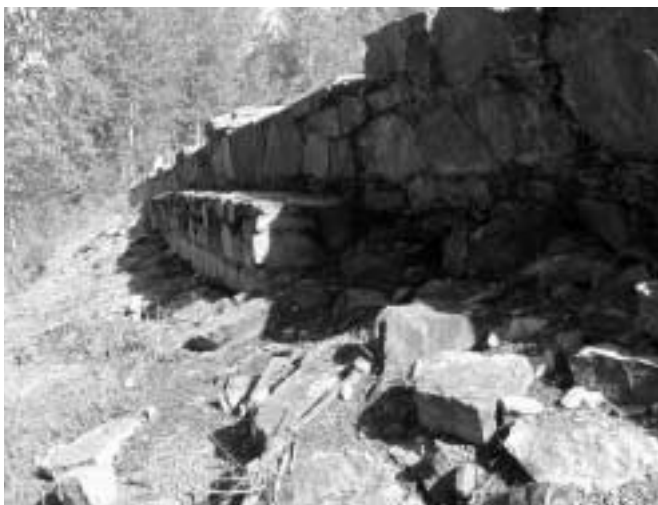
Figure 47: Damage to the parking lot guardwall at The Loop

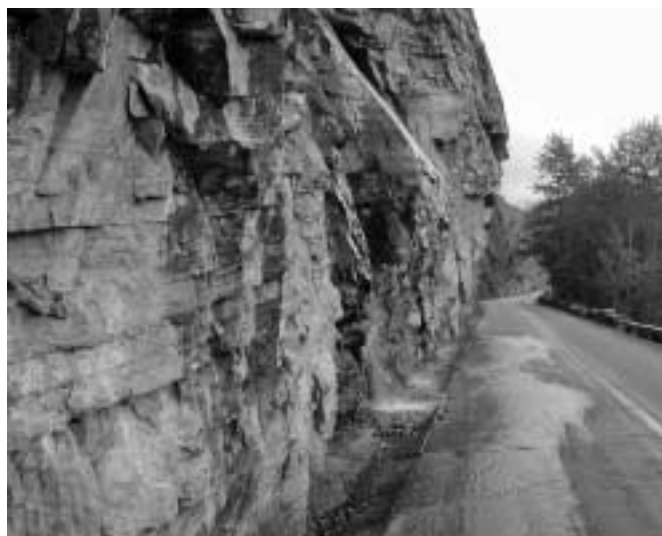
Figure 48: Poor drainage in the vicinity of MP 25

at MP 24.8 and MP 24.9, and additional cross drains, drop inlets, and scuppers should be installed. The CMP headwall at MP 25 (Sta. 927+10) is damaged causing erosion into the Road and should be repaired and a bollard added to regain roadway width. Approximately 300 feet of guardwall is low and is tipping at MP 24.66; 125 feet of stone retaining wall is low and tipping at MP 24.7. These should be rehabilitated and founded on eight-foot slabs (at a minimum). Scuppers are recommended in these walls for drainage of the sheet flow across the road. The veneer is peeling from the concrete on the retaining wall at MP

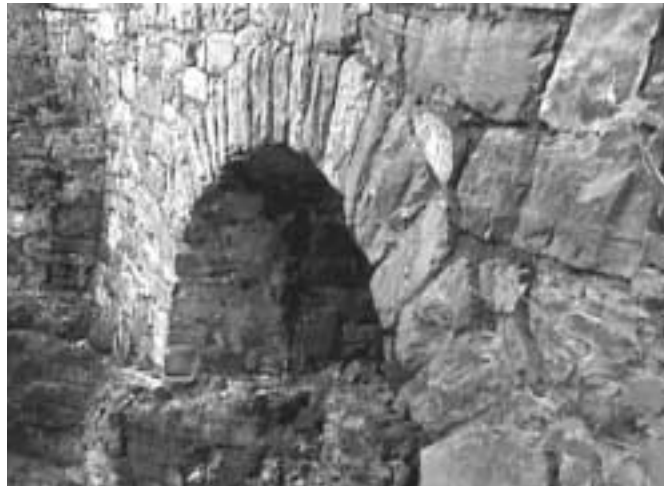
egress for a short section of CMP carrying local drainage across the roadway. The rock wall inside support for this structure has completely collapsed leaving a void approximately three feet deep by six feet wide by eight feet long under the roadway. The inside foundation material has dissipated and the arch foundation on the outside of the roadway has deteriorated significantly. The condition of this structure is considered very poor to critical, as illustrated in Figure 50.

Figure 49: Crystal Point Arch

This site should be monitored carefully by maintenance personnel and all necessary actions should be taken to restore the roadway to a safe and serviceable condition. The FHWA has completed an initial study of the arch and has developed a repair option that appears to be consistent with structural, safety, and historic preservation values. It is recommended that the FHWA

plans and designs, or a similar repair option, be implemented as a priority consideration at this site.

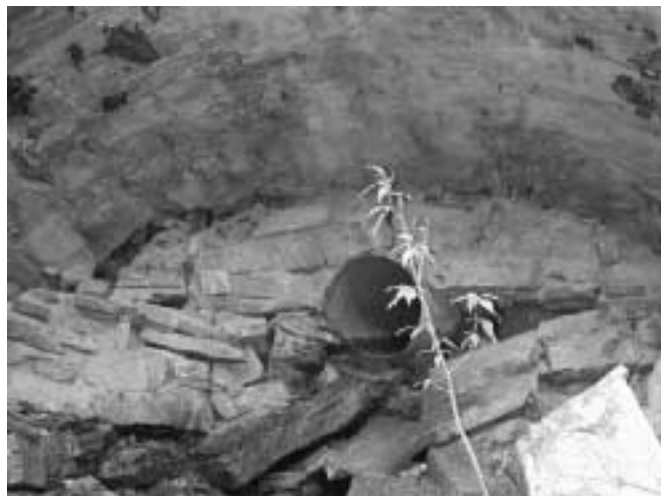
The entire upstream support of the arch has collapsed (Figure 50) and most of the roof shows fractures and failure stress, causing progressive subsidence of the roadway and pavement section. Continued roadway subsidence will further restrict drainage features, accelerate roadway failure, and detrimentally affect the highway user. Complete failure of this weakened roadway section could occur at any time, which could result in immediate Road closure and potential loss of life and property.

Figure 50: Damage underneath Crystal Point Arch

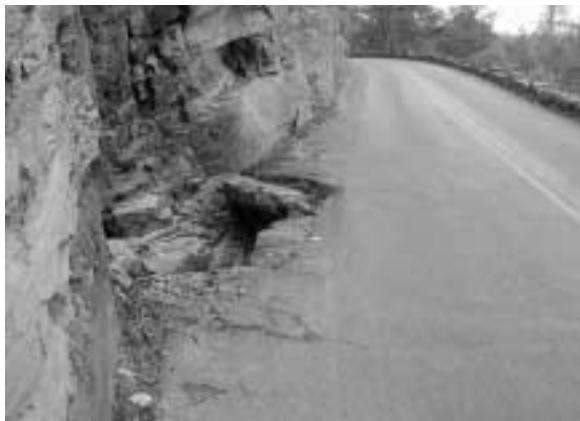
Figure 51: Catch basin damage near MP 25.2

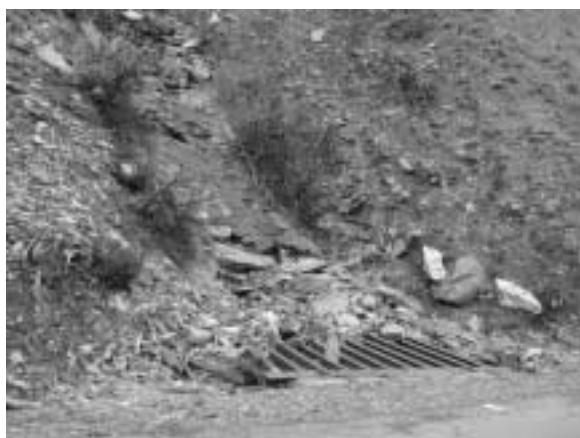
Figure 52: Drainage improvements are needed near MP 25.4

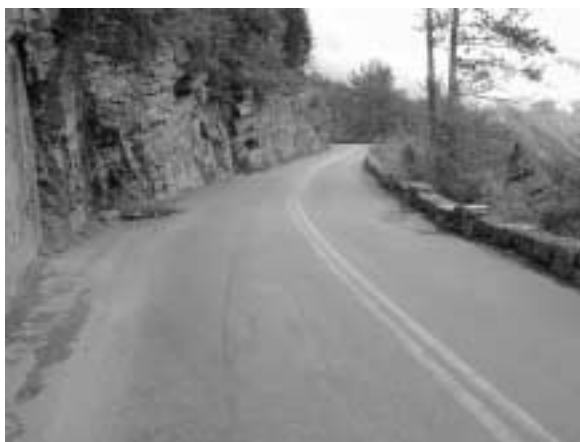
Figure 53: Rock scaling and roadway template adjustment are needed at MP 25

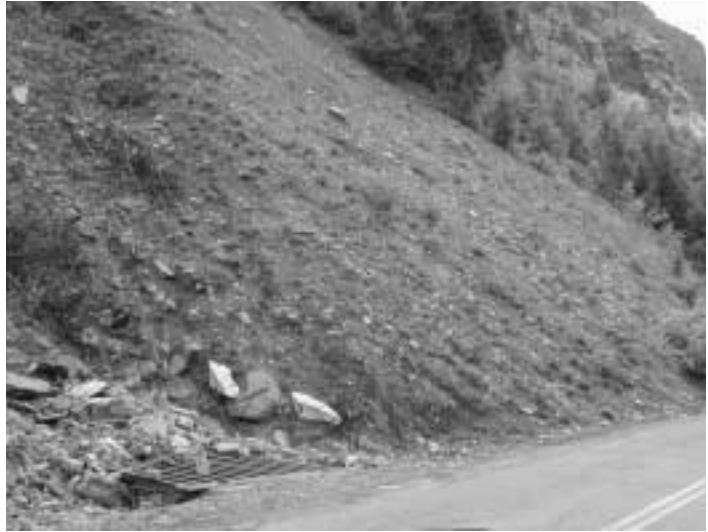
Figure 54: A good opportunity for bio-remediation in the vicinity of MP 25.5

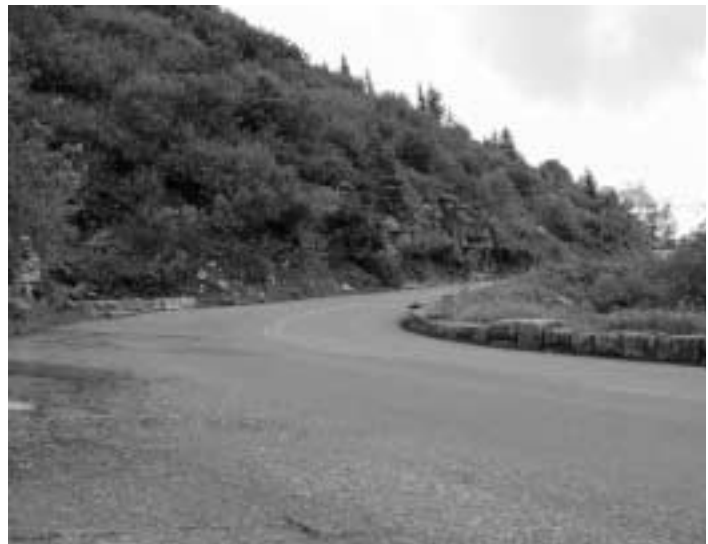
Figure 55: Roadway template adjustment is needed to correct guardwall height deficiency near MP 26

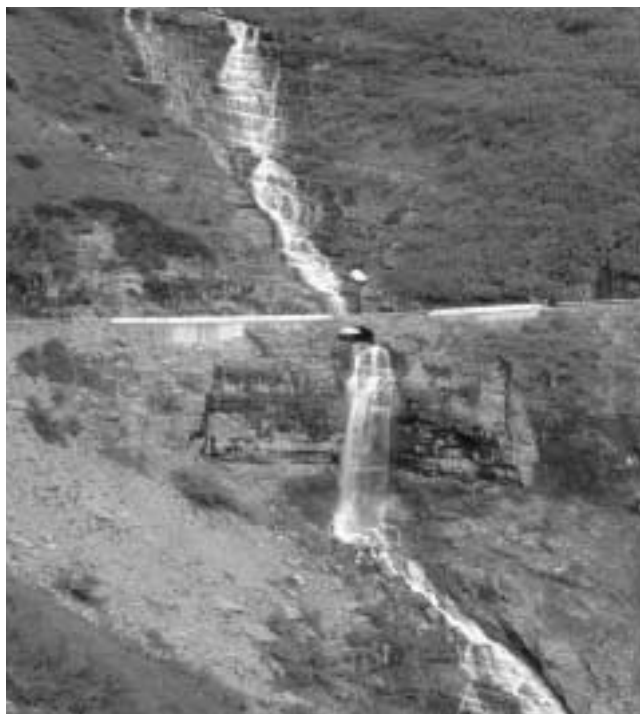
Figure 56: Significant rehabilitation work is needed in the vicinity of Haystack Creek

- **Haystack Creek Segment: MP 26.9 to 28.0.** Significant rehabilitation work is required in this segment (Figure 56). Drainage improvements consist of re-lining or replacement of CMP and installation of scuppers at MP 27; repairing the undermining of the concrete box at MP 27.1; and repair of the existing inlets, or providing new inlets and bollards at MP 27.6, MP 27.7, and MP 27.9. The headwall on the CMP at MP 27.3 (sta. 638) requires replacement. Rip-rap end treatment is needed on the drainage crossing at MP 27.7 (Sta. 646). Scaling of rock faces above the roadway is needed between MP 27 and MP 27.1 and at MP 27.6 (Figure 57). The uphill soil cut at MP 27.8 requires stabilization, preferably using bio-remediation. The retaining wall at MP 27 shows impact damage, and approximately 300 feet is in need of repair. Subsidence is occurring behind the retaining wall at MP 27 (Sta. 626) and roadway template rehabilitation is required. Approximately 400 feet of the retaining walls between MP 27 and MP 27.2 have experienced avalanche damage and the top 4 feet of the walls should be rebuilt. The retaining wall at MP 27.4 (Sta. 635-635+50) shows subsidence and leaning and will require a roadway slab of at least 12 feet anchored with piles and tie-backs and

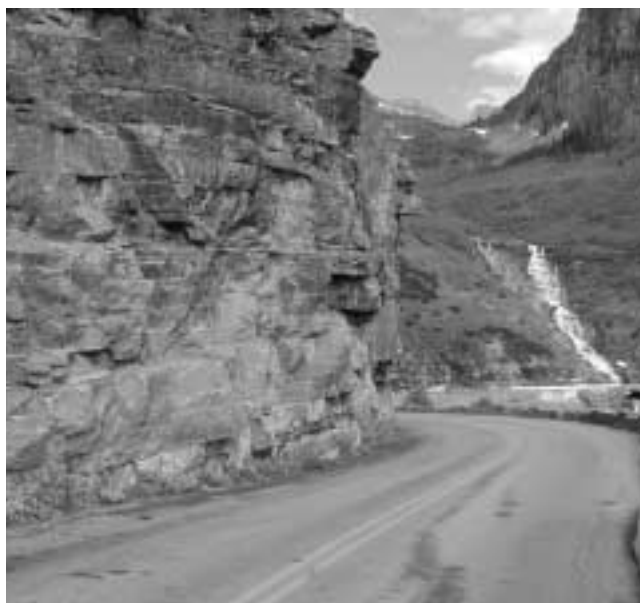
Figure 57: Rock scaling, retaining and guardwall work, and template adjustment are needed near Haystack Creek

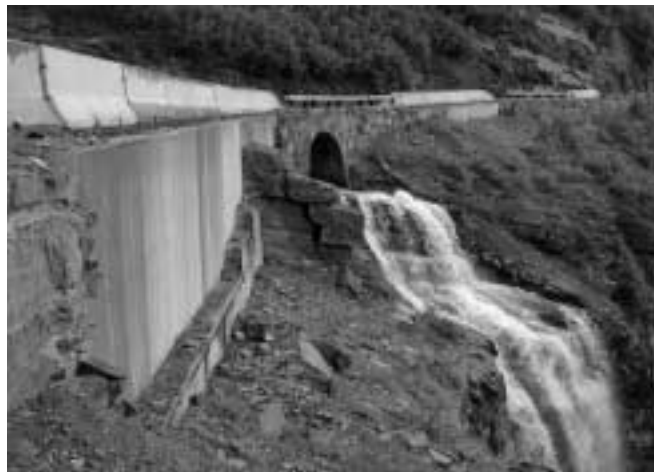
- Haystack Creek Stream Crossing: MP 27.3.** This concrete box culvert with stone parapets is 23 feet long (transverse to roadway) by ten feet wide (parallel to roadway). This structure is in good condition with the minor exception of needed stone masonry repointing on the parapets. The stonework on the walls does not meet historic standards and the existing rock should be removed and rebuilt to historic standards.
- Big Bend Segment: MP 28.8 to 30.0.** Drainage in the vicinity of the Weeping Wall (Figure 59) requires improvement. Inlet grates and bollards are needed at MP 28.8 (Sta. 683), MP 28.9 (Sta. 686-691), MP 29.3 (Sta. 697+75), MP 29.6 (Sta. 704+80 and 709), MP 29.7 (Sta. 712+50) and MP 29.8 (Sta. 720-721). Scaling is needed on the rock cuts at MP 29.6 (Sta. 710+50), MP 29.7, and MP 29.9 (Sta. 718+75-723). Rock scaled in this area may be suit-

Figure 58: Haystack Creek stream crossing

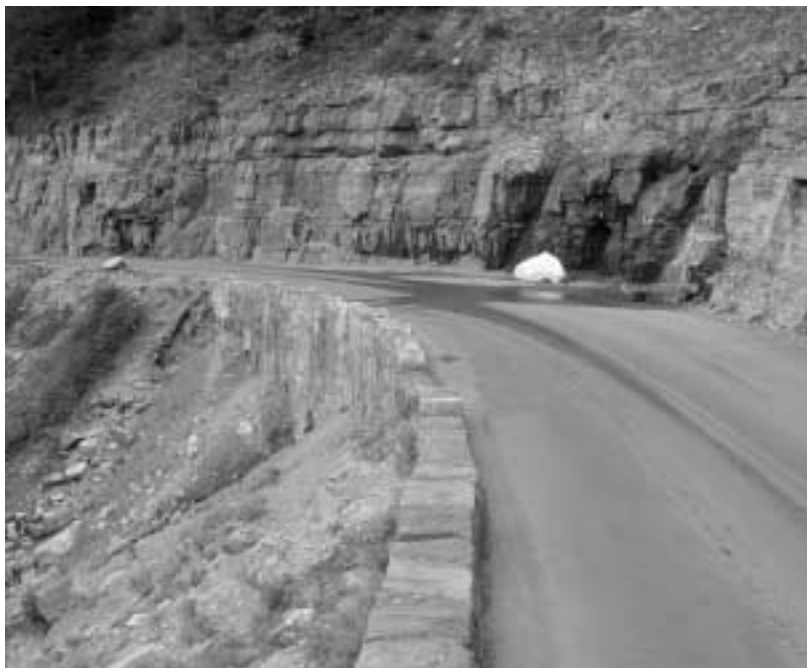
able for rebuilding of stone masonry walls. A wire mesh bio-remediation should be installed at MP 29.9 (Sta. 717) to address the erosion of this uphill soil cut. The retaining wall at MP 29 (Sta. 688) shows grout cracking and mortar pointing and patching is required. The retaining wall at MP 29.7 (Sta. 712+50) (Figure 60) is

Figure 60: Drainage, retaining wall, and roadway rehabilitation are all needed at MP 29.7

tipping and the roadway shows movement, and will require a roadway slab of at least 8 feet, anchored with piles and tie-backs, and rebuilding of the top 4 feet of guardwall for about 100 feet. The reinforced concrete tie-back wall at MP 29.9 (Sta. 720-721) has missing stone facia and should be replaced to historic standards. Guardwalls are tipping and subsidence is evident at MP 28.9 (Sta. 685-687), MP 29 (Sta. 688-691), MP 29.4 (Sta. 697+50), MP

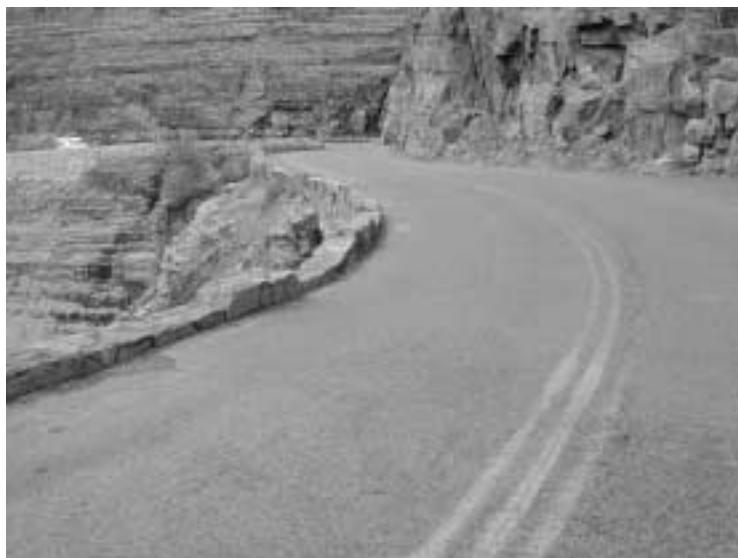
Figure 61: Significant roadway rehabilitation is needed in the vicinity of Triple Arches

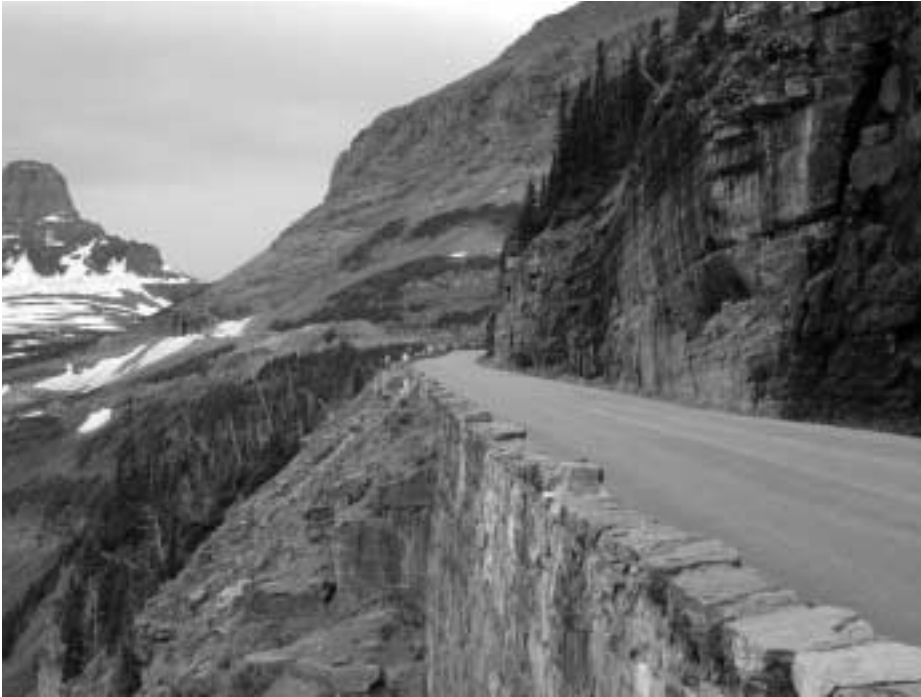
Figure 62: The roadway above Triple Arches

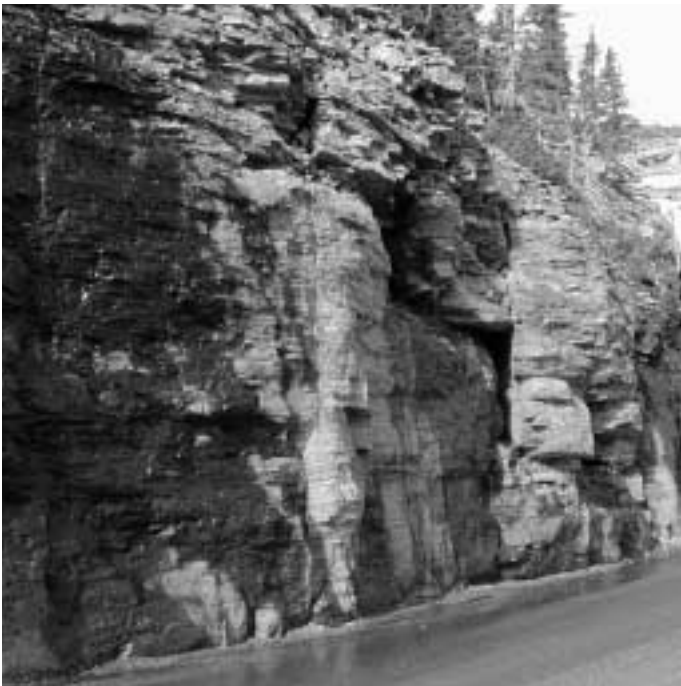
Figure 63: Rock scaling is needed near MP 31.8

- ***Oberlin Bend***
Segment: MP 31.8 to 32.6. Rock scaling at MP 31.8 and shoulder work is needed for most of this segment (Figure 63). Guardwalls are extensively damaged and need replacement, preferably on footings in this area. Some roadway template work is needed, which can be accommodated with roadway slabs and overall shouldering.

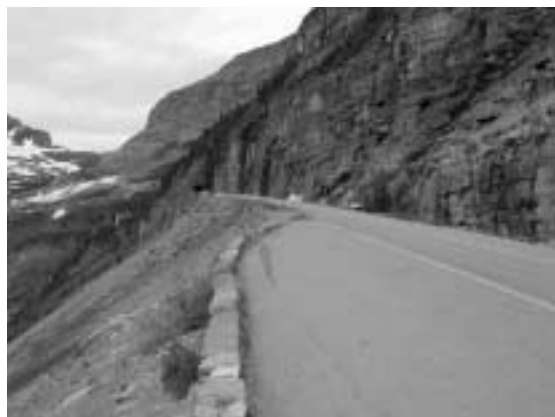
Figure 64: Drainage improvements, rock scaling, and roadway rehabilitation are needed in the vicinity of MP 33

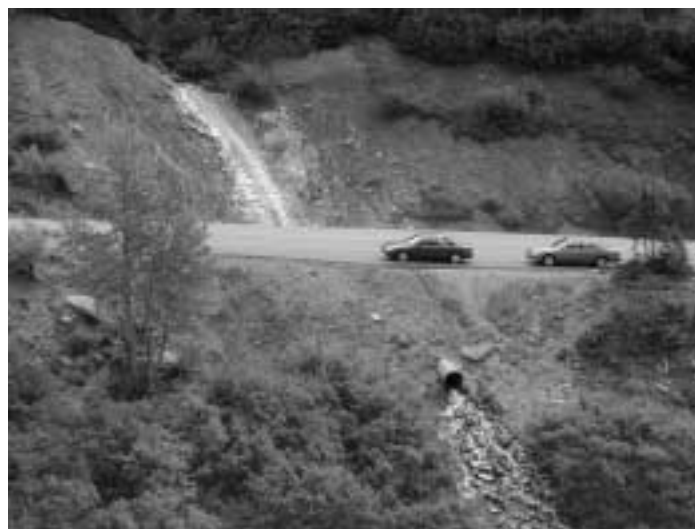
Figure 68: A culvert at MP 34.8

peded to the culvert's head-wall creating damage (Figure 68). One solution in this situation is to create energy dissipation by using rocks strategically placed in the flow. The area of MP 35 (Figure 69) shows progressive erosion of the steep soil cuts and exposed boulders could tumble onto the roadway. Bio-remediation and minor realignment of the roadway would provide for a catch ditch (Figure 70).

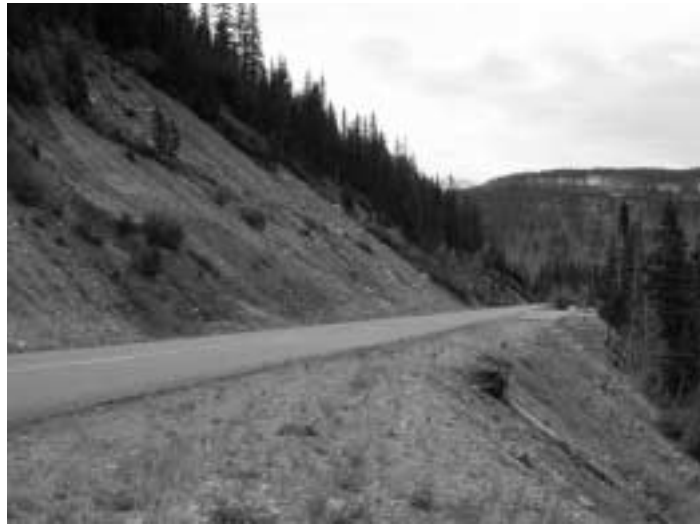
Figure 69: Raveling soil slopes at MP 35

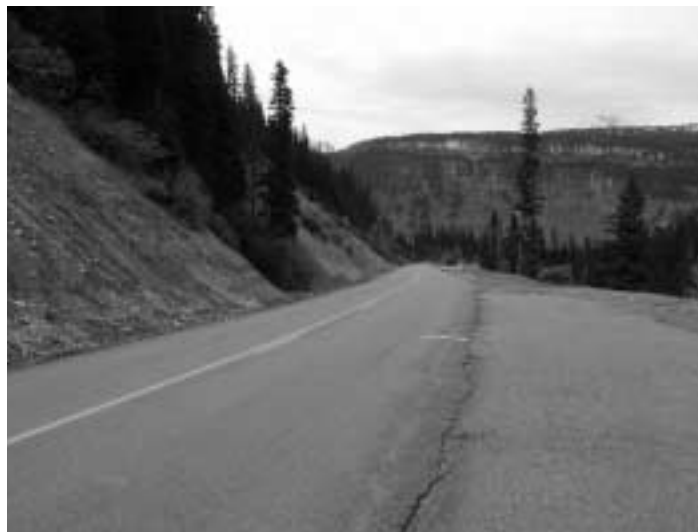
Figure 70: Minor roadway realignment would facilitate slope rehabilitation

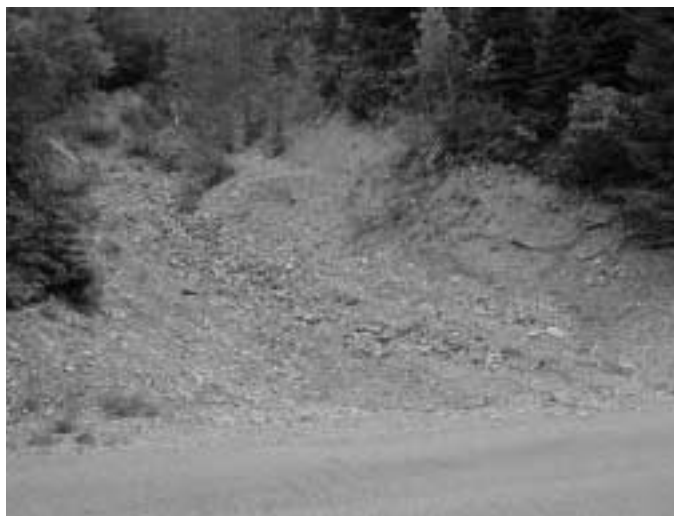
Figure 71: Debris flow near MP 36.5

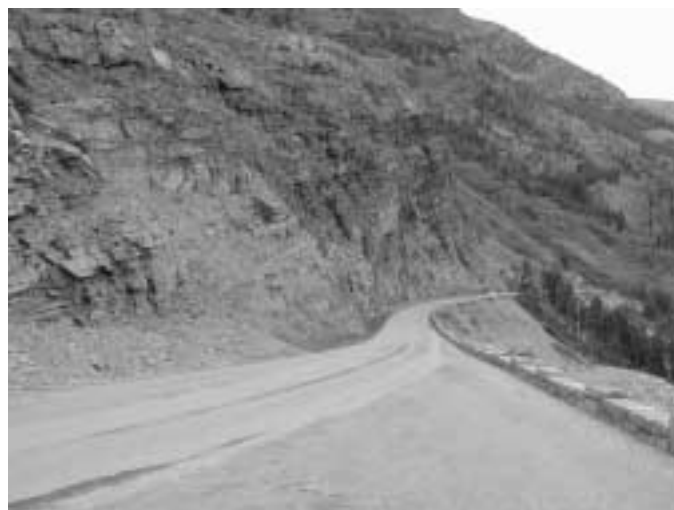
Figure 72: Rock scaling and guardwall rehabilitation is needed near Dead Horse Point

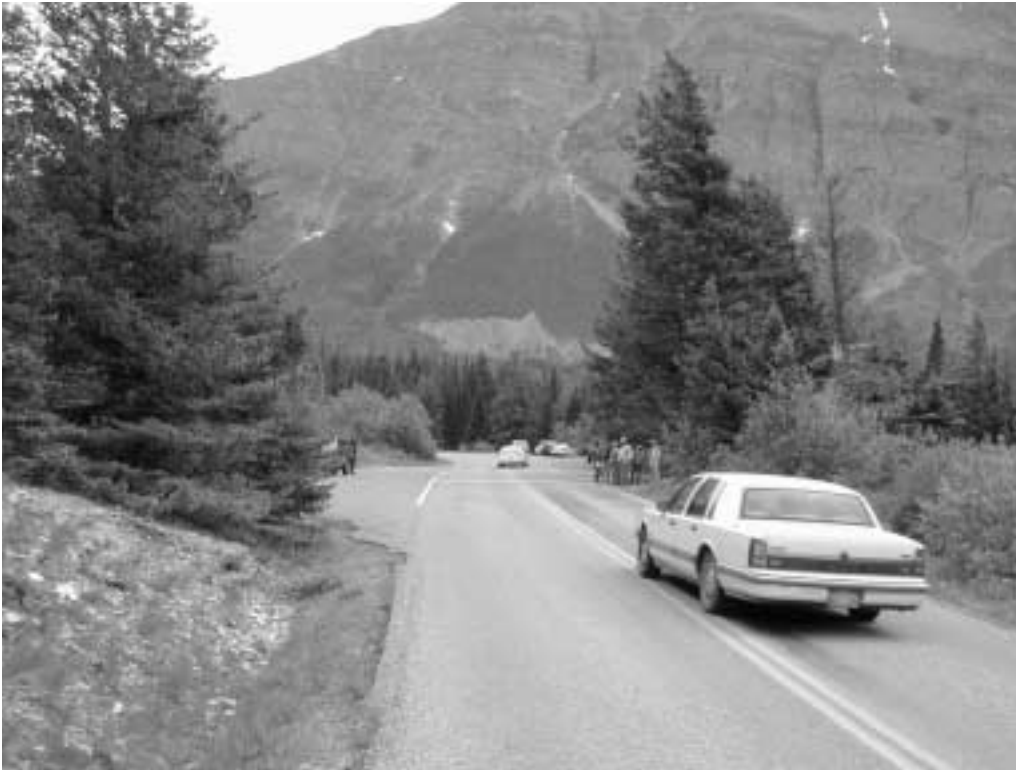
Figure 73: Road realignment is recommended for the pedestrian area near MP 43

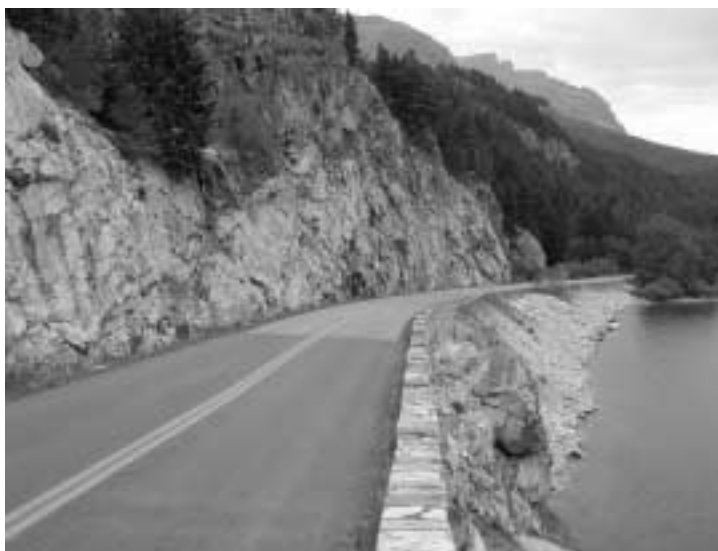
Scaling is needed in this same area, and rock scaled may be used in the wall rehabilitation efforts. Additional drainage is needed in the vicinity of MP 43.3, and the addition of a three-inlet collection system with one outflow is recommended.

Figure 75: Roadway and guardwall rehabilitation and rock scaling are needed in the vicinity of MP 43.3

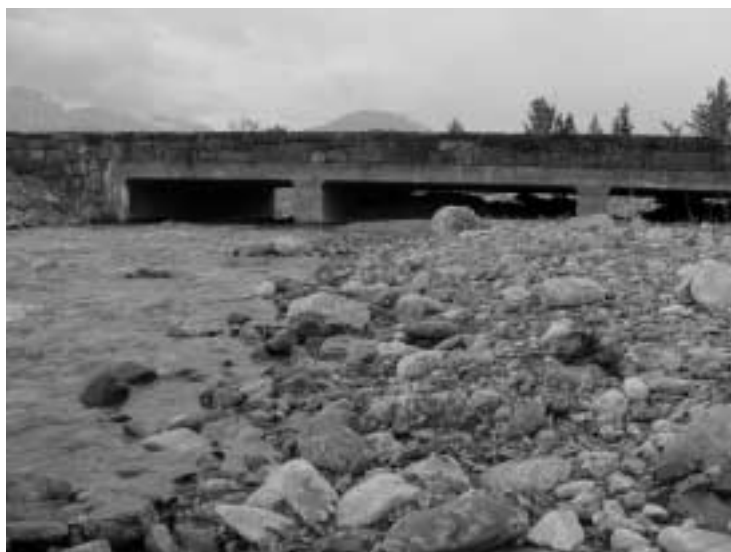
Figure 76: High bed loading in Divide Creek
